New York State Department of Transportation

Red Flag NB2358W013

BIN: 1065318

Location: Span 247, Girder G19 at Pier 247

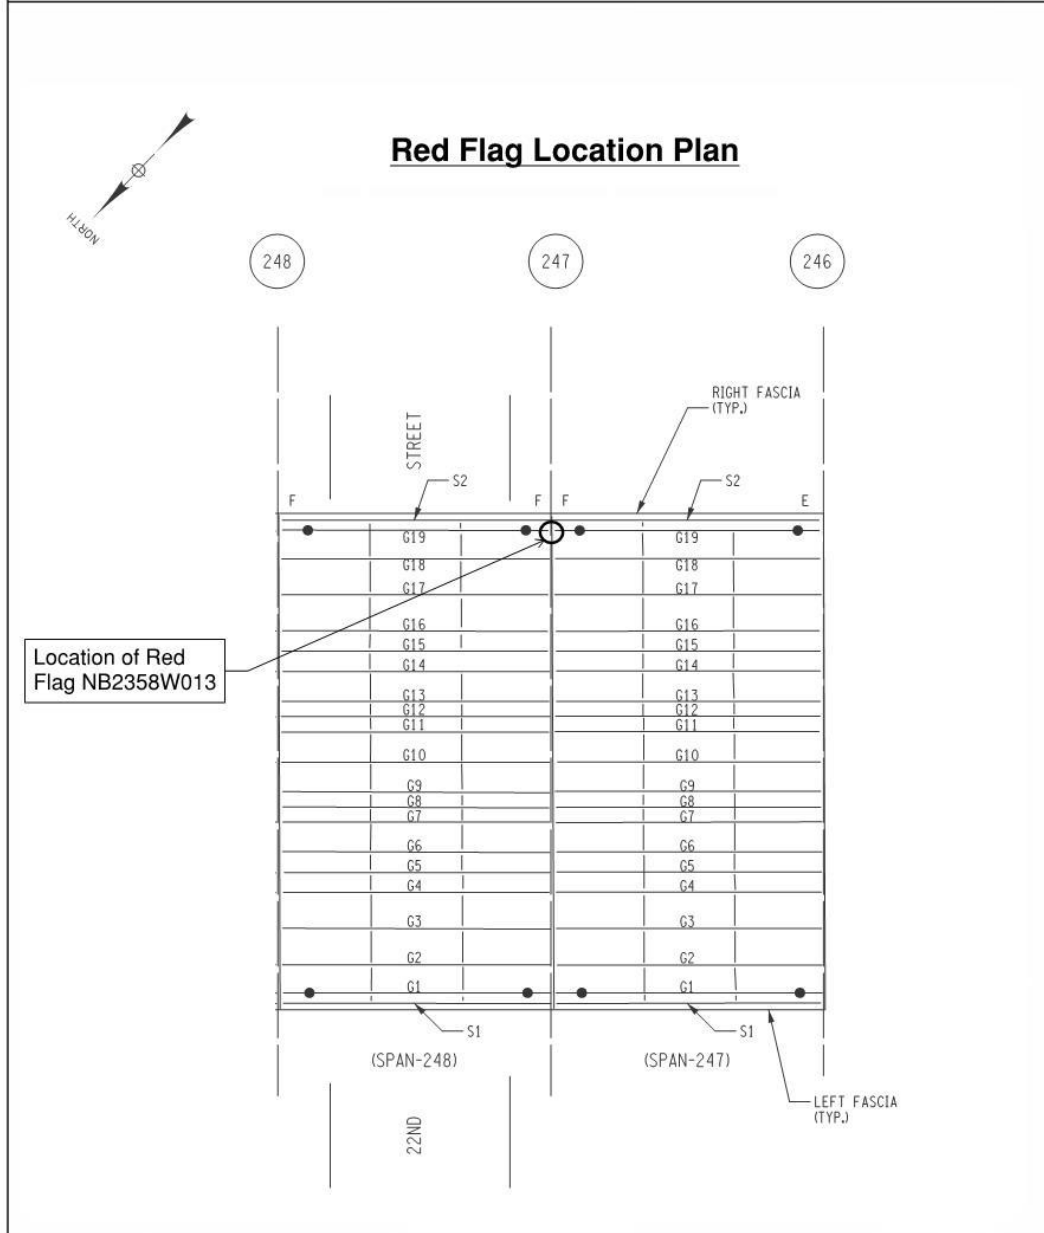
Flag PhotographsPhoto Number: **1**Photo Filename: **23_Flag Location Plan.jpg**Gowanus Expressway
2023 Biennial Inspection - Field SketchBIN: 1065318Team: AA/TSDate: 05/30/2023Span: 247Location: Girder G19 at Pier 247

**Attachment Description: Flag Location Plan**

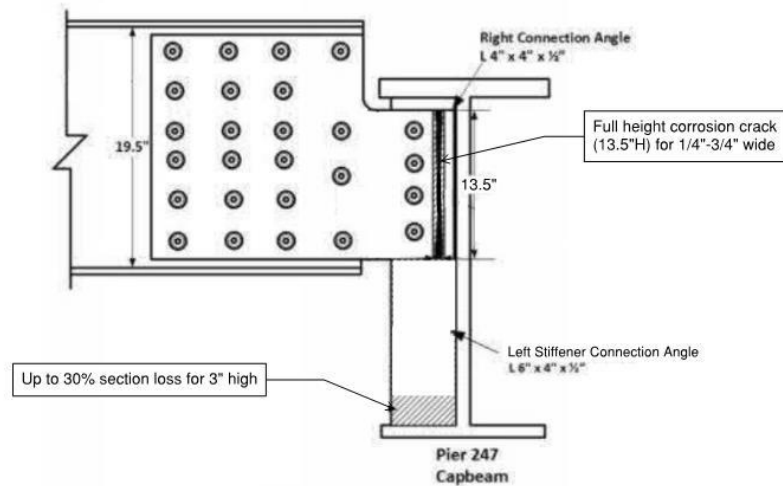
Right Face of Girder G19

Attachment Description: Flag Condition Sketch

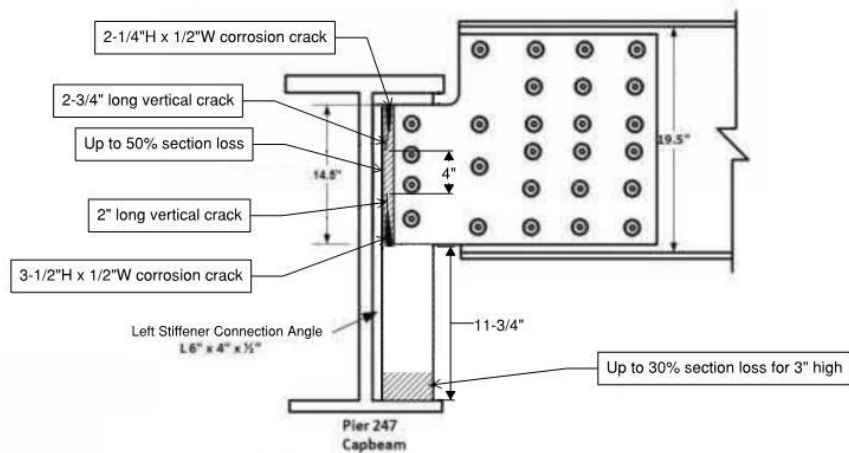
Left Face of Girder G19

-As-measured web thickness is approximately 0.606"

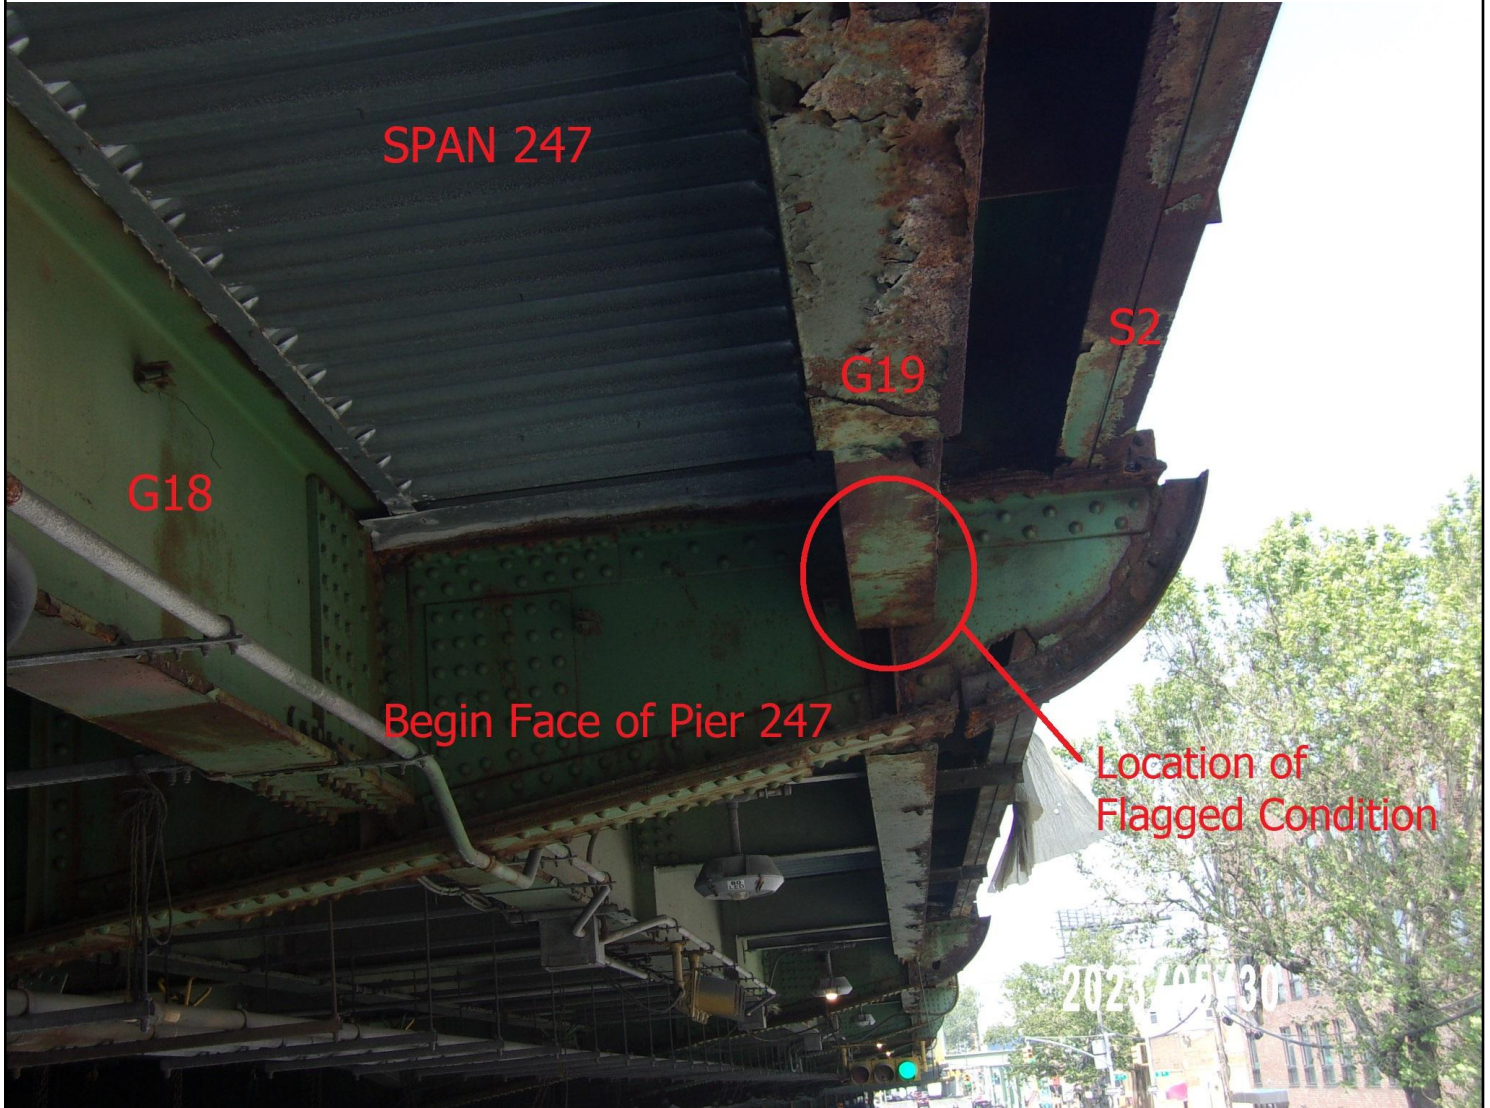
Photo Number: 3

Attachment Description: General view of the flagged condition at Girder G19 in Span 247 at Pier 247. Looking End.

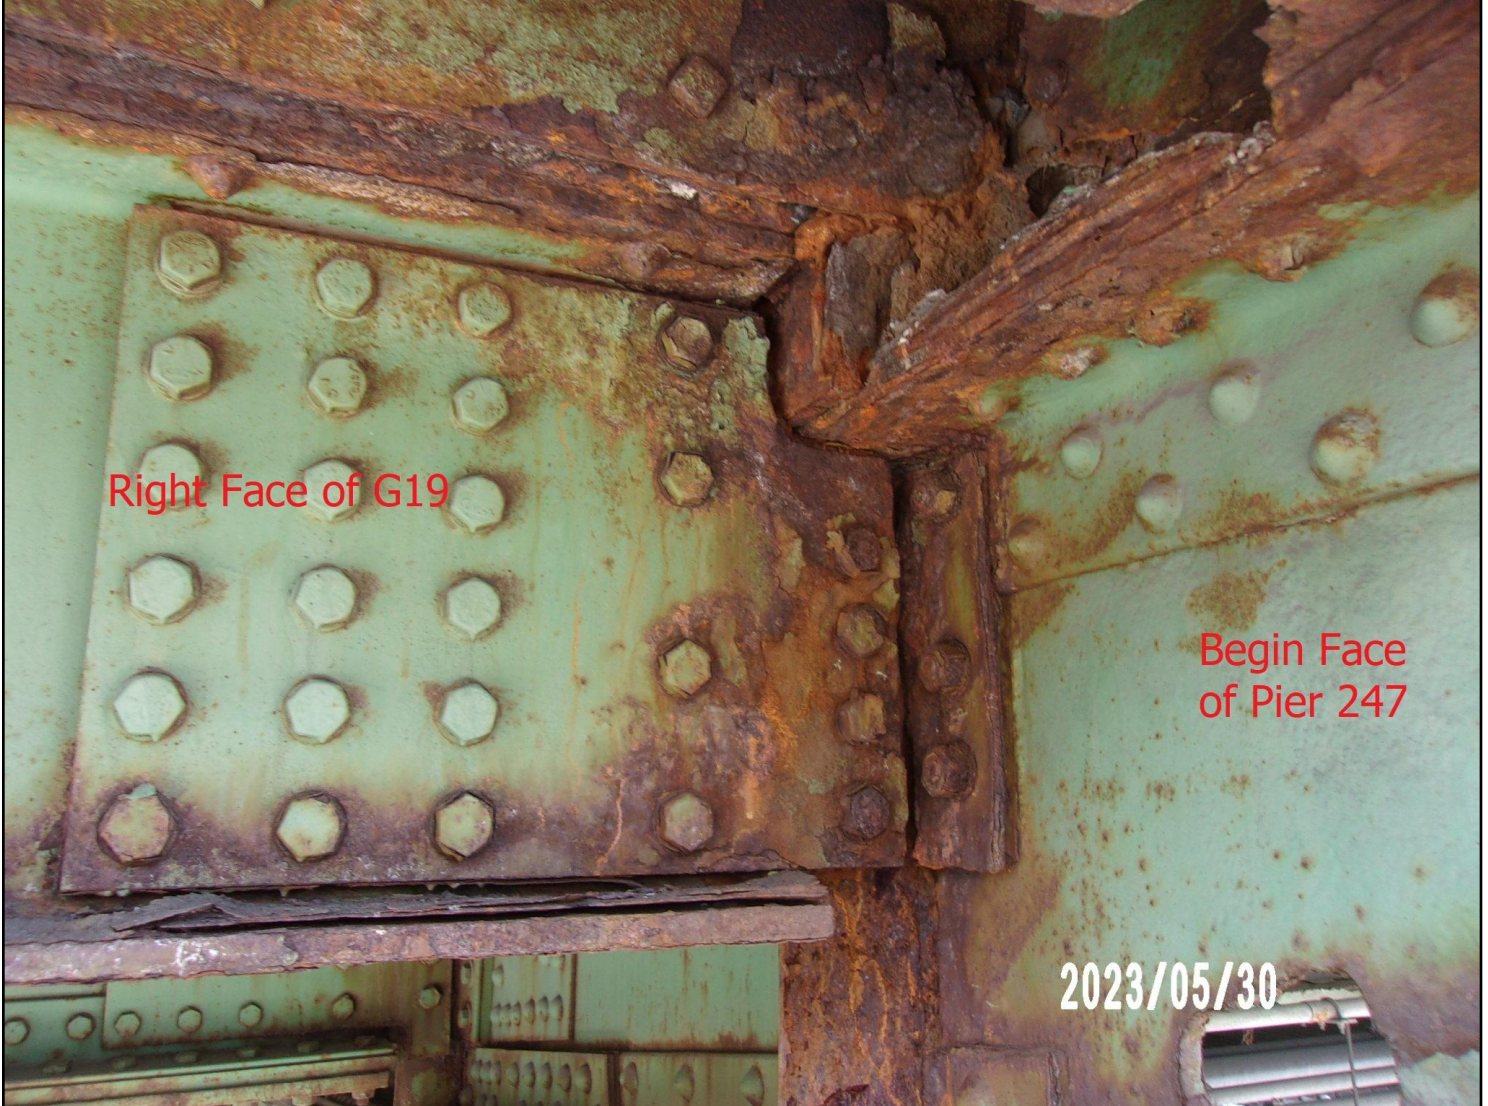
Photo Number: 4

Attachment Description: Close up general view of the right face of Girder G19 in Span 247 at Pier 247. Looking End-Left.

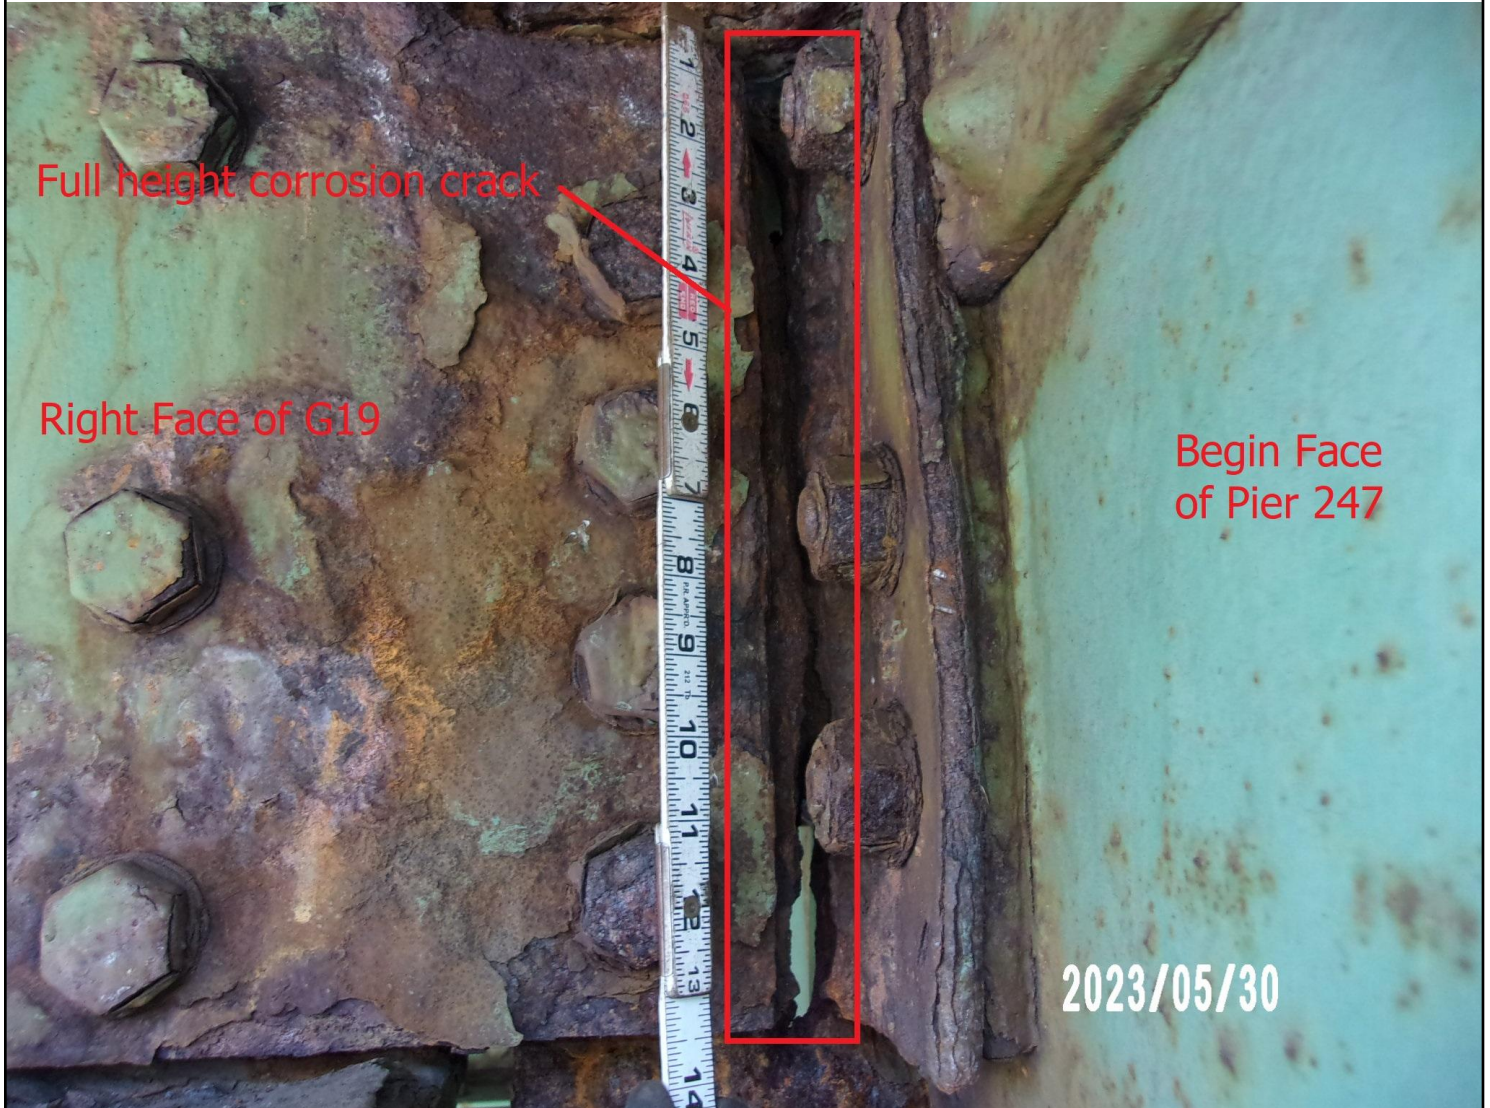
Photo Number: 5

Description: The right connection angle at Girder G19 to the pier cap at Pier 247 exhibits a full height vertical corrosion crack for 1/4"-3/4" wide in the fillet section (previously noted to be 5" H x 3/4" W vertical corrosion crack at the lower fillet section and an 8.25" H x 3/4" W vertical corrosion crack at the upper fillet section with 90% section loss for the remaining 1.25" of the connection angle height). (Photo 5)

Attachment Description: The right face of Girder G19 in Span 247 at Pier 247. The right connection angle exhibits full height vertical corrosion crack for 1/4"-3/4" wide in the fillet section. Looking Left.

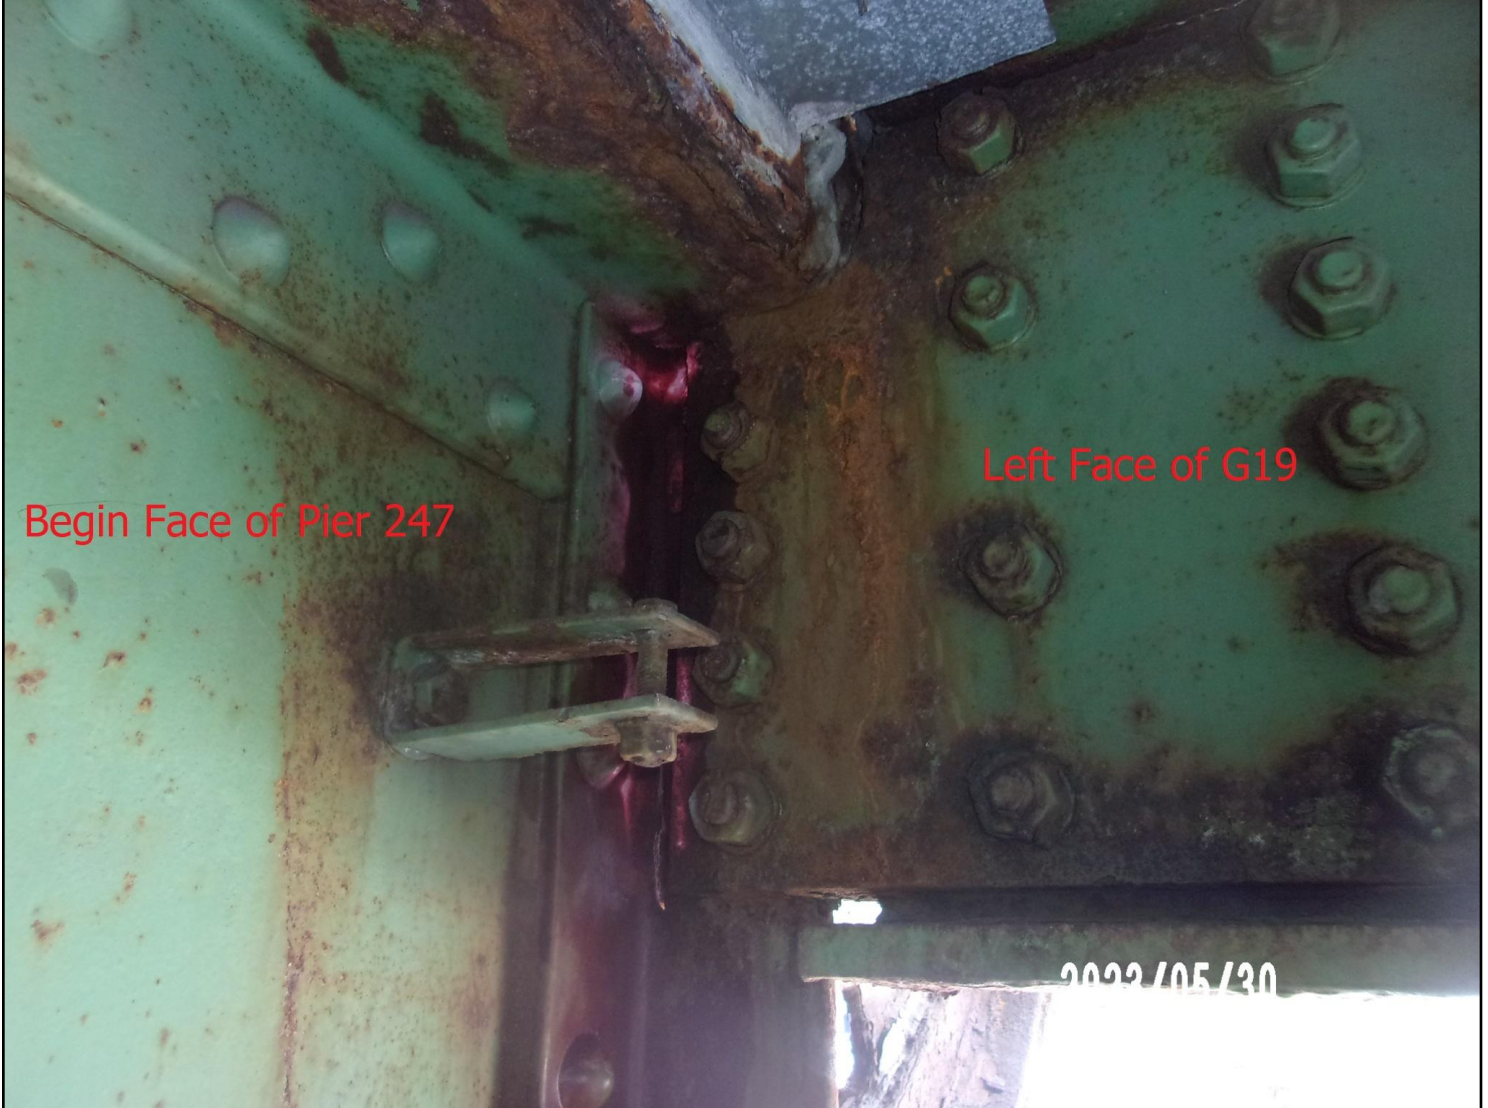
Photo Number: 6

Attachment Description: Close up general view of the left face of Girder G19 in Span 247 at Pier 247. Looking Right.

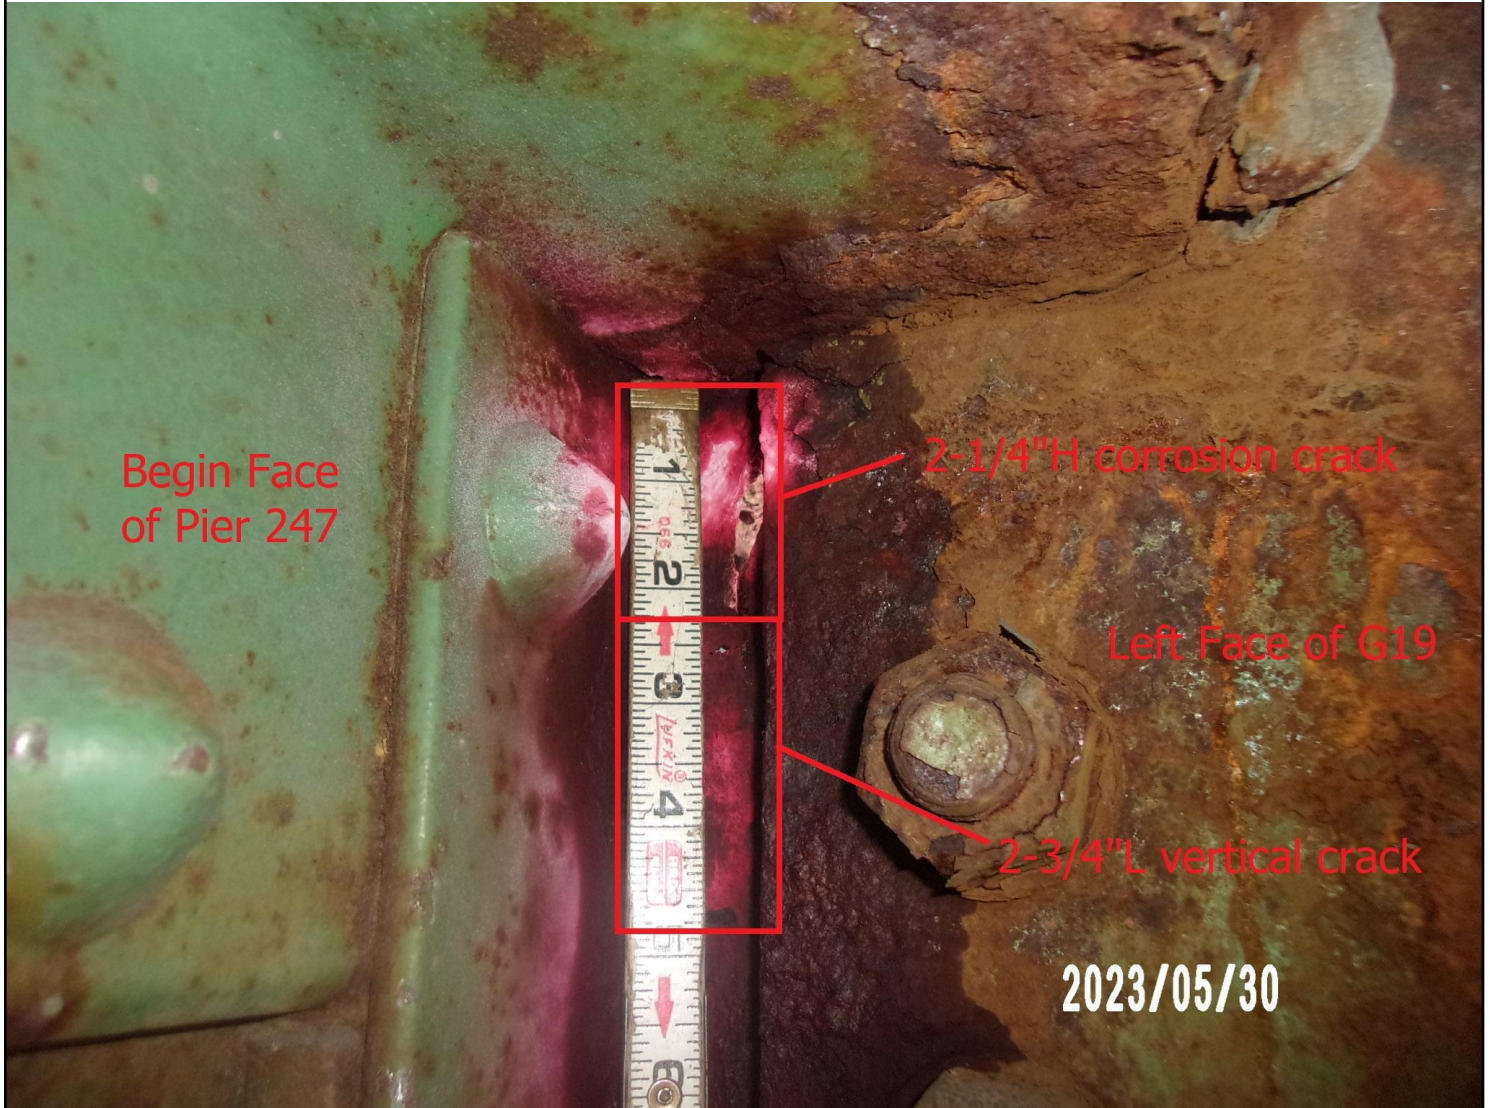
Photo Number: 7

The left stiffener connection angle exhibits a corrosion crack measuring 2-1/4"H x 1/2"W (previously noted to be 2" long) followed by 2-3/4" long vertical crack (previously noted to be 2-1/2" long) at upper portion of fillet (Photo 7). Additionally, there is a 3-1/2"H x 1/2"W corrosion crack followed by 2" long vertical crack (previously noted to be 5" long corrosion crack) at lower portion of fillet (Photo 8). The remaining fillet area of the connection angle between the two cracks is approximately 4" high and exhibits up to 50% section loss (Photo 9). The remaining height of the stiffener connection angle below the girder exhibits up to 30% section loss for the bottom 3" high for the full width (Photo 10).

Attachment Description: The left face of Girder G19 in Span 247 at Pier 247. The left connection angle exhibits 2-1/4"H x 1/2"W corrosion crack followed by a 2-3/4" long vertical crack at the upper fillet section. Looking Right.

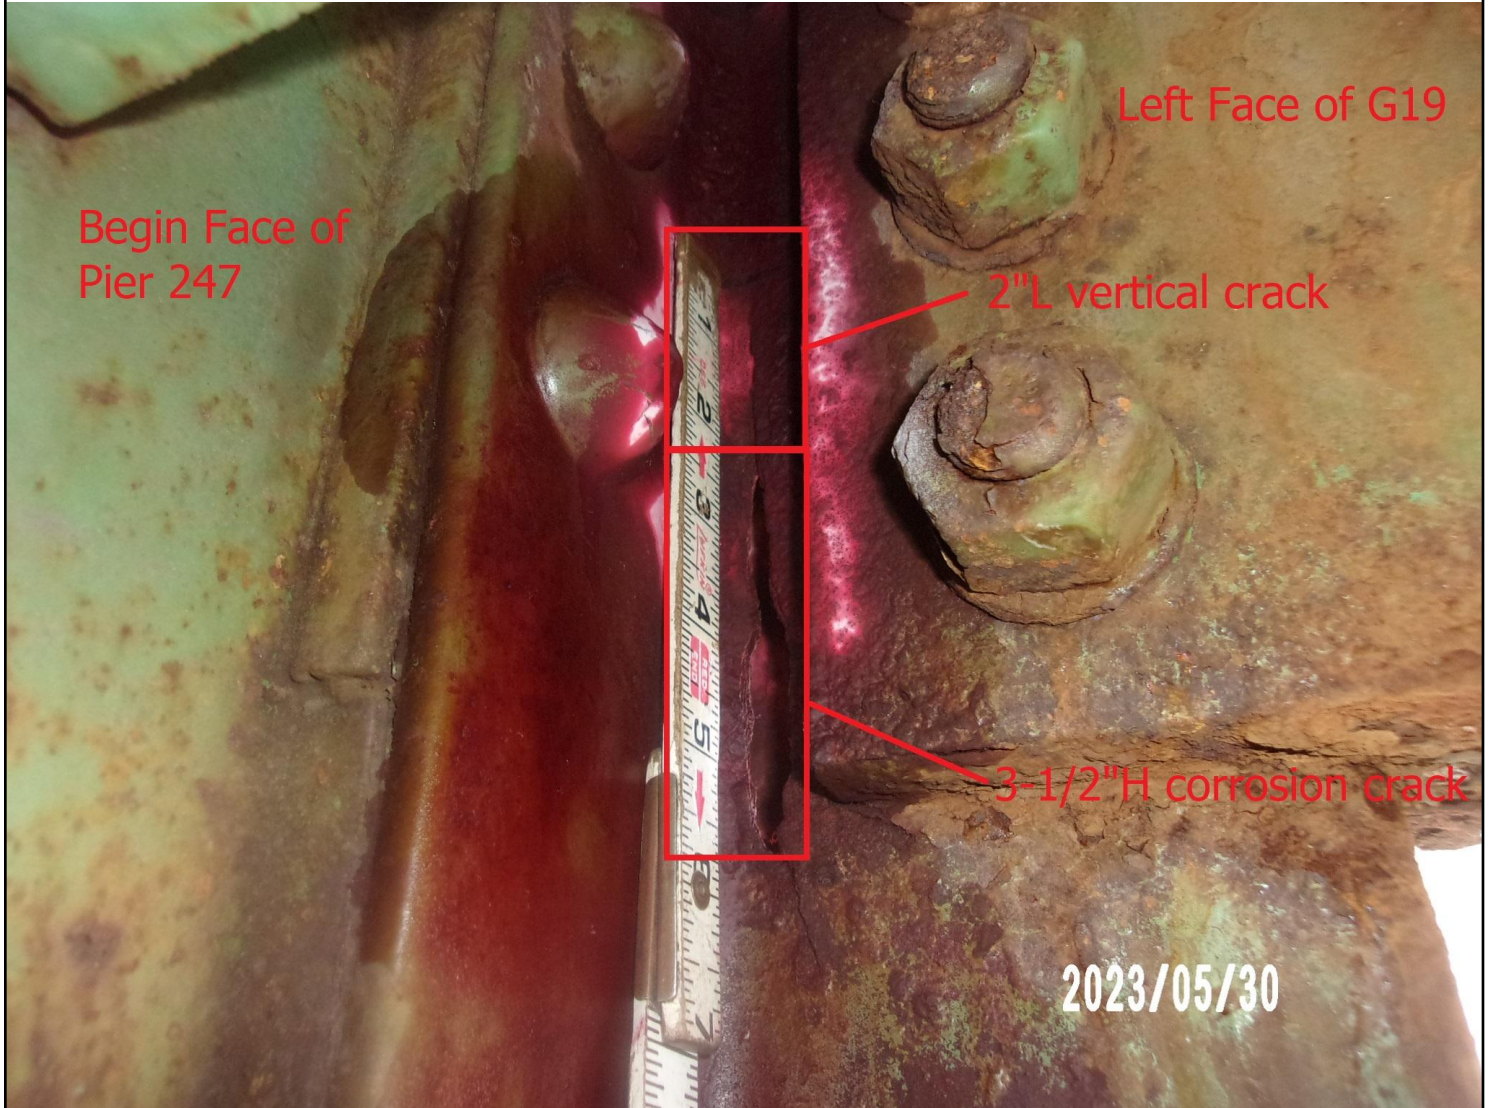
Photo Number: 8

Attachment Description: The left face of Girder G19 in Span 247 at Pier 247. The left connection angle exhibits 3-1/2"H x 1/2"W corrosion crack followed by a 2" long vertical crack at the lower fillet section. Looking Right.

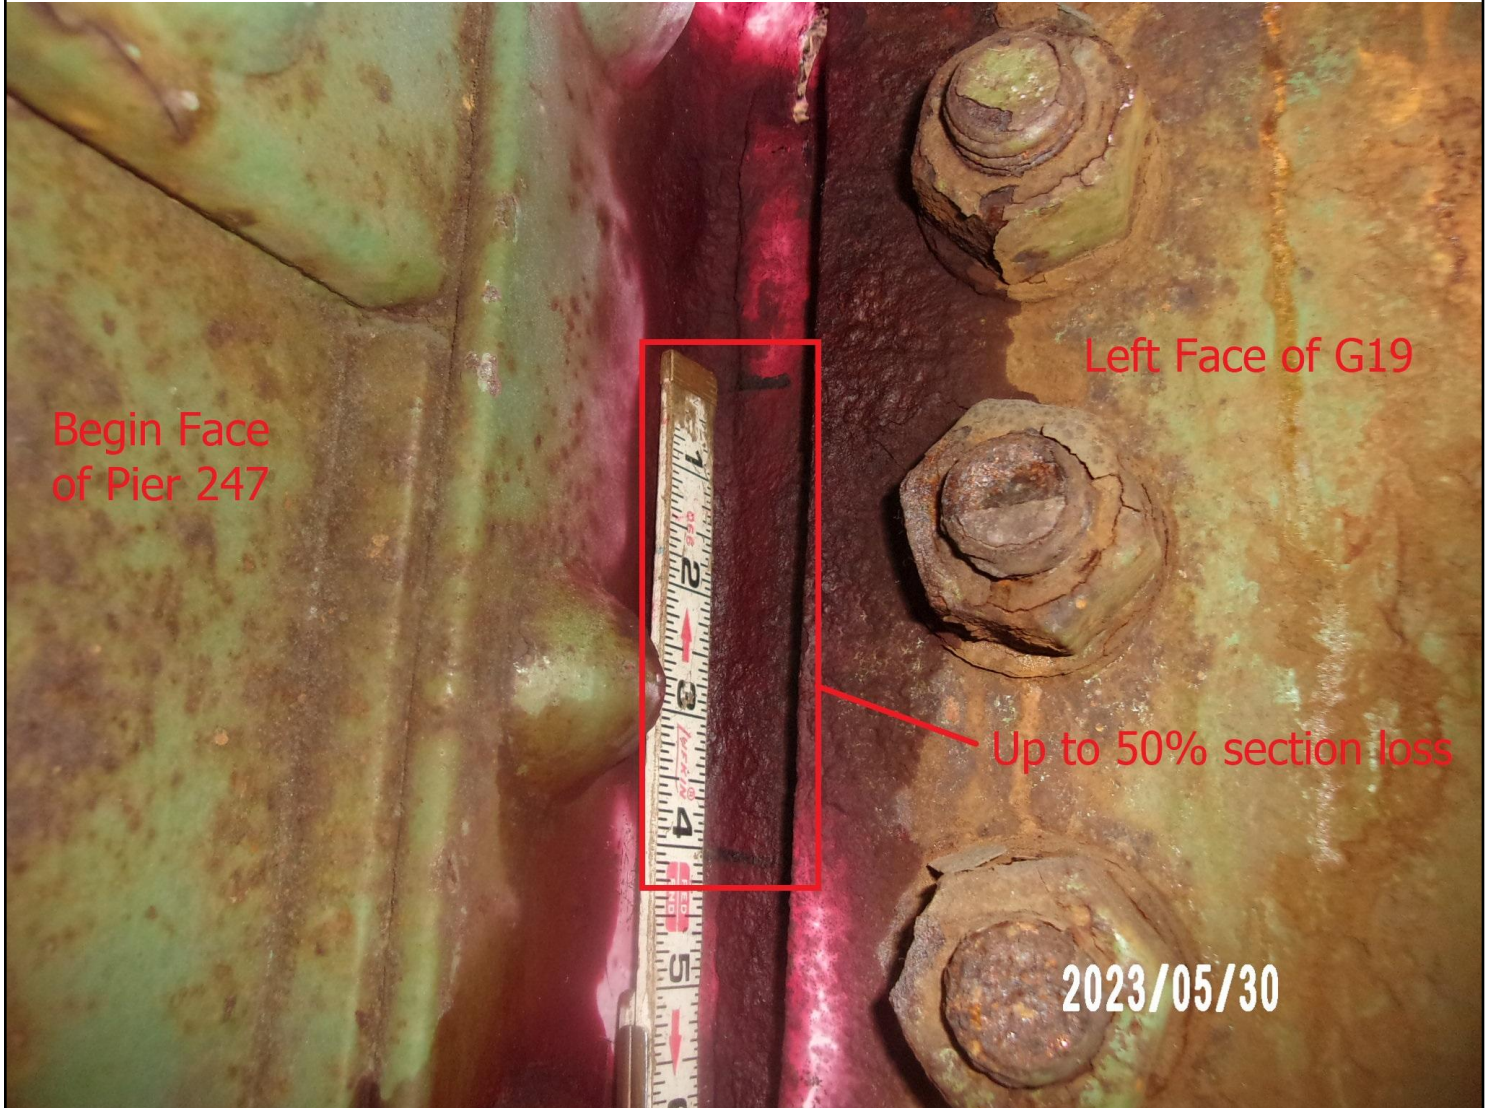
Photo Number: 9

Attachment Description: The left face of Girder G19 in Span 247 at Pier 247. The left connection angle exhibits up to 50% section loss in the fillet section between the cracks at the top and bottom of the angle. Looking Right.

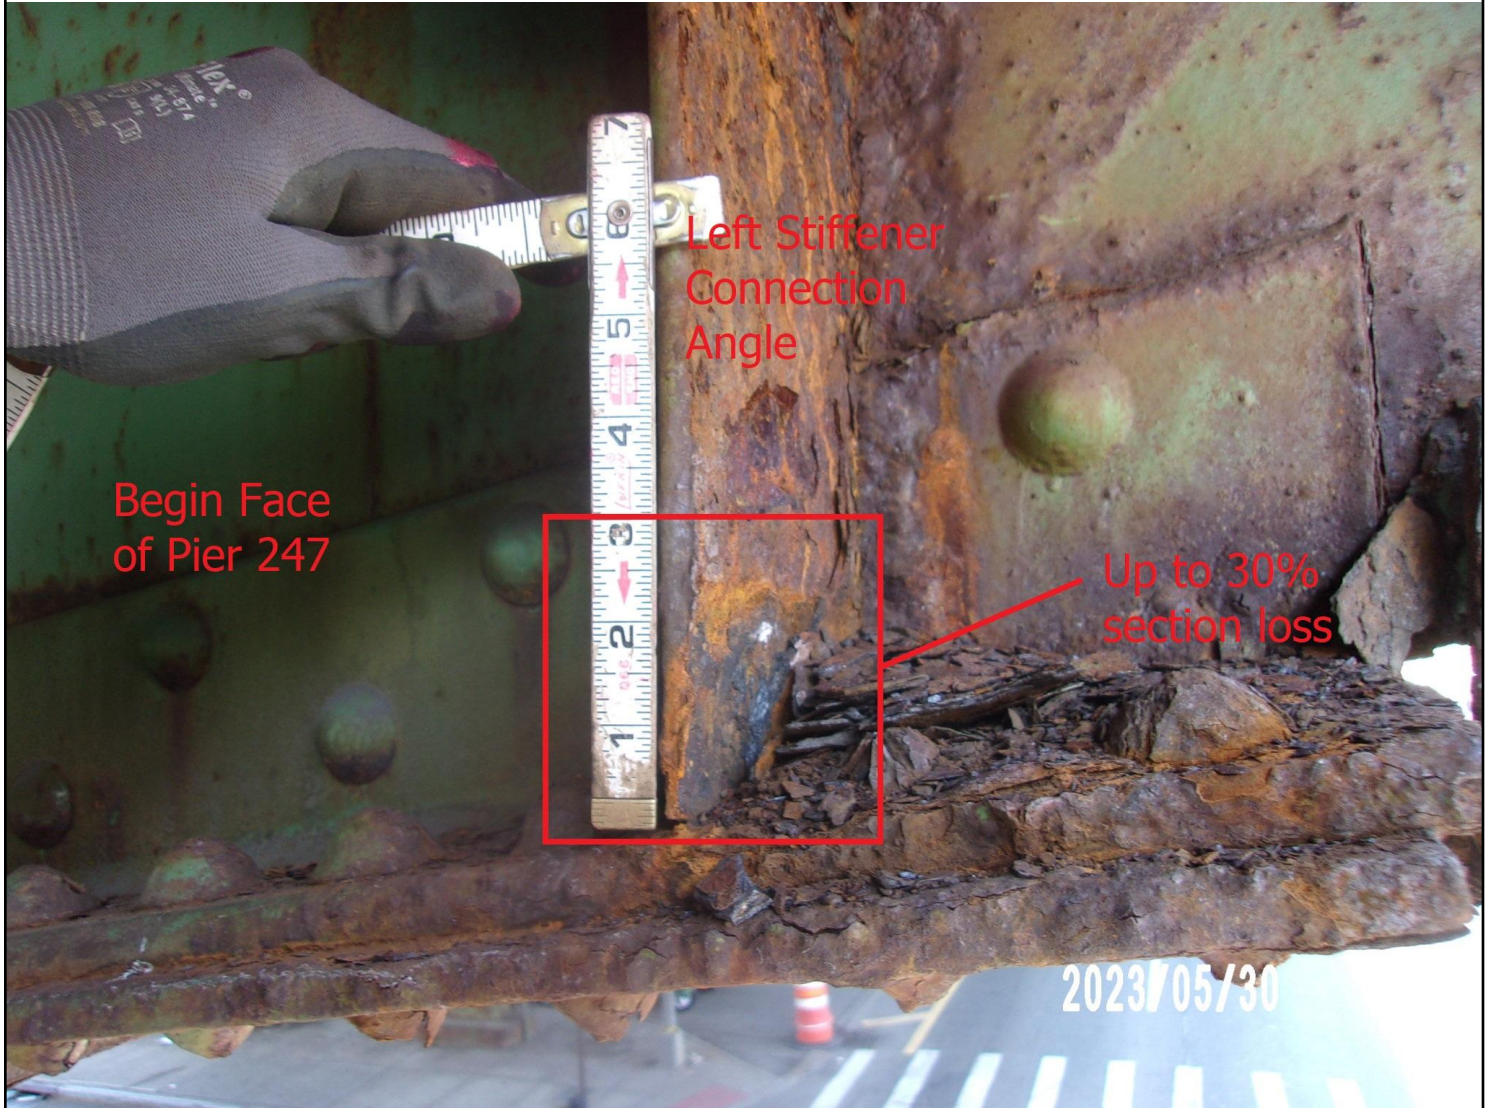
Photo Number: 10

Attachment Description: The base of Girder G19 left stiffener connection angle in Span 247 at Pier 247. The bottom of the stiffener connection angle exhibits up to 30% section loss for 3" high. Looking End.
